Manhole Inspection Summary

Manhole # S29Q1_003MH

Insp Date: **2/19/08 1:13 PM**

Location Address: **918 Bridgeview Rd.**

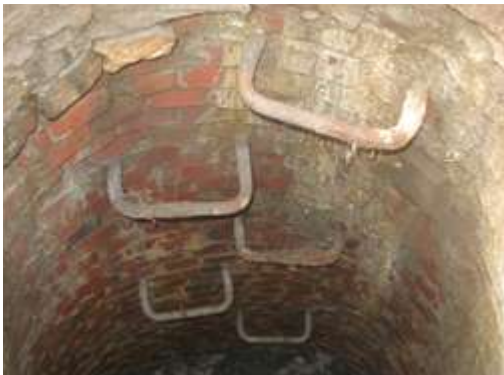
Steps Count: **5** Missing: **0** ☒ **Corroded**

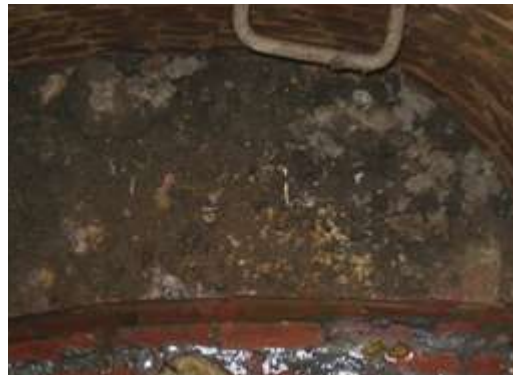
Defect 2

Slight debris on bench

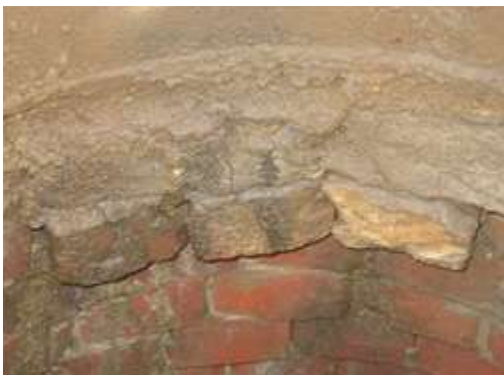
Defect 1

Condition: ☐ Sound ☐ Cracked ☐ Root Intrusion ☒ **Loose Brick** ☐ Deteriorated

Chimney infiltration

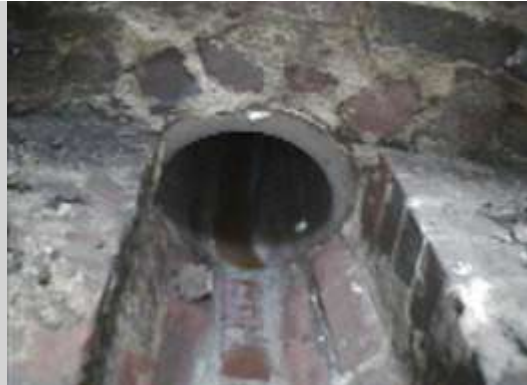
12 O'Clock Outflow

Pipe Height: **8.4** (in.) Rod and Bar (Angled)
Pipe Material: **Clay** ☐ Pipe Lined
Invert Depth: **8.91** (ft.) Flow Characteristics: **None**
Deposits: ☒ None ☐ Mud ☐ Sludge ☐ Debris ☐ Grease
Silt Depth: (in.) Deposits Extent:
Infiltration: **None** Pipe Seal Cond: **Sound**

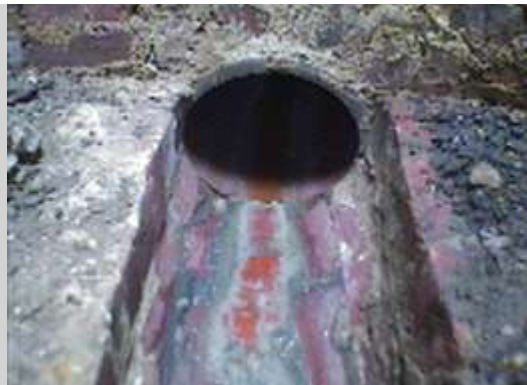
6 O'Clock Inflow

Pipe Height: **8.4** (in.) Rod and Bar (Angled)
Pipe Material: **Clay** ☐ Pipe Lined
Invert Depth: **8.59** (ft.) Flow Characteristics: **None**
Deposits: ☒ None ☐ Mud ☐ Sludge ☐ Debris ☐ Grease
Silt Depth: (in.) Deposits Extent:
Infiltration: **None** Pipe Seal Cond: **Sound**
